FACT SHEET No. 2

MCP-01 Decommissioning Recommendations

TOTAL E&P UK PLC is preparing to decommission the concrete gravity base platform MCP-01. Finding the best disposal arrangements for the platform, which balances environmental, social, technical safety, risk to personnel and economic aspects is very important to the company.

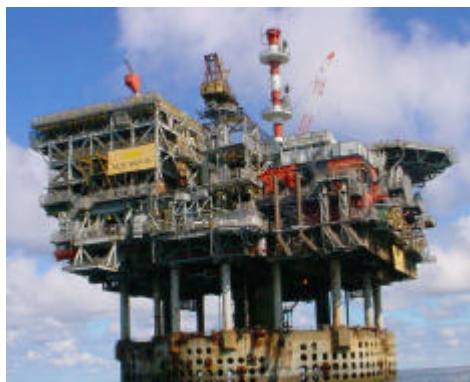
RECOMMENDATION FOR TOPSIDE FACILITIES

In accordance with the UK and Norwegian legislation and OSPAR Decision 98/3, the complete removal of the topsides has been the only decommissioning option considered. The topsides will be removed using conventional offshore methods of working. Work will also be integrated with the Frigg Field decommissioning project from which significant synergy effects are expected.
